Case Study

# Troubleshooting Interference Issues during Radio Head Deployments with CellAdvisor

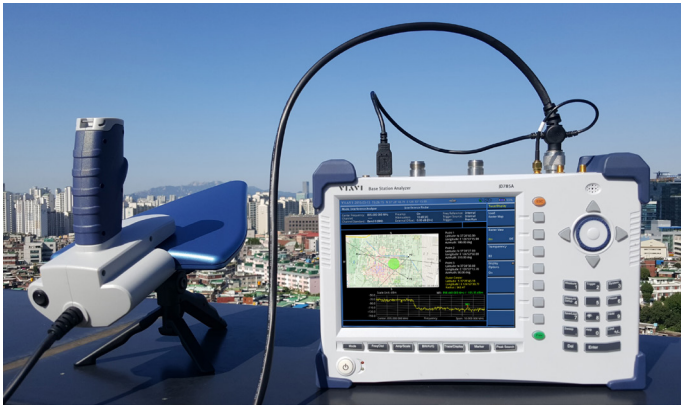
The CellAdvisor™ spectrum analyzer function significantly reduces the time it takes to identify interference issues. Using this function with the CellAdvisor JD785B and a directional Yagi antenna, an engineer was quickly able to identify interference on the uplink: it was seen across the 10 MHz LTE spectrum in use.

To meet trial deadlines, the VIAVI NEM partner was not able to remove the source of interference. Instead, they used CellAdvisor measurements to relocate the radio head. Consequent measurements indicated a reduced level of interference near the new location. The radio was brought back in service. This let our NEM partner complete their customer proof-of-concept in a timely manner.
